Infrared Thermography Survey

DEMO REPORT

*Prepared by:
Brenton Ward*

Thursday, July 23, 2009

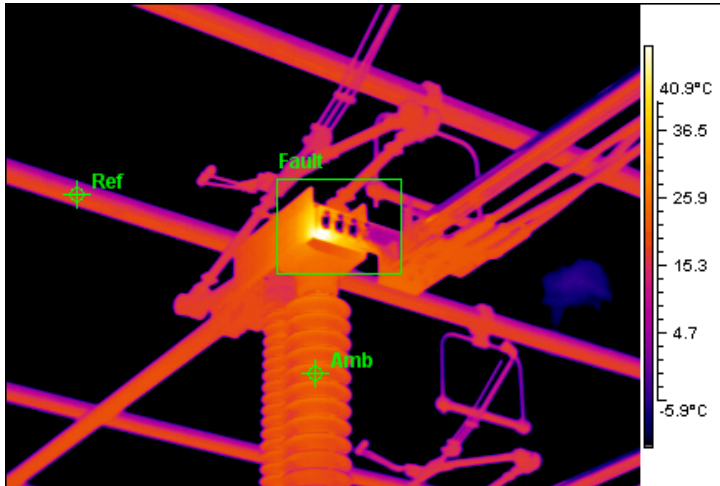
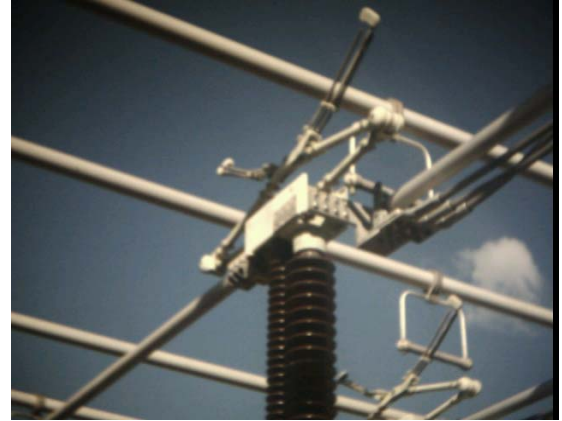
FileName	IR000123.JPG				
CreateTime	8/12/2008 2:42:28 PM				
Emissivity	0.98	Distance	5.0m		
Max Temp	50.7°C	Min Temp	-30.0°C		
Lens	35mm / 22°FOV		Filter	None	
Background Temp	21.4°C				
Location:	NSW XXXX Substation				
Equipment:	Switch				
Measured Load (Amps)	NM	Rated Load		% Load	
Ambient	24	Temp	51	Rise Over	27
Obj. Priority	Med	Subj. Priority	Low	Avg. Priority	Med
Environmental:	Partially overcast, 22°C Ambient. Easterly sea breeze.

With load unknown, subjective priority only based on qualitative information. Target is developing a very localized hot spot now exceeding 50°C. Similar components were only slight above ambient. Load is constant given the type of operations (aluminium smelting).

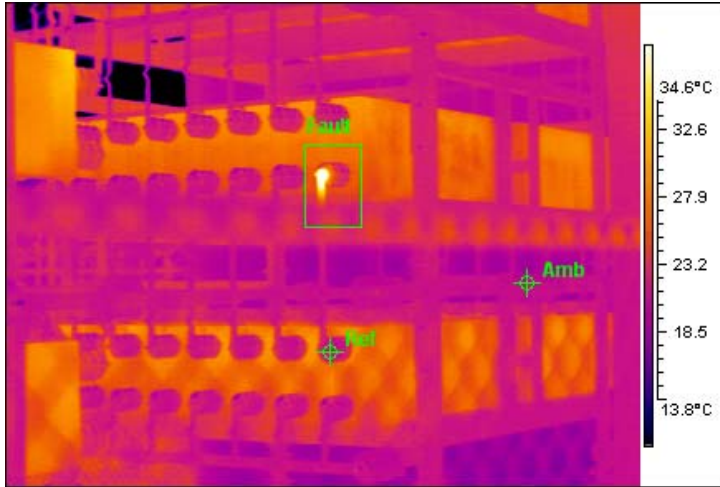
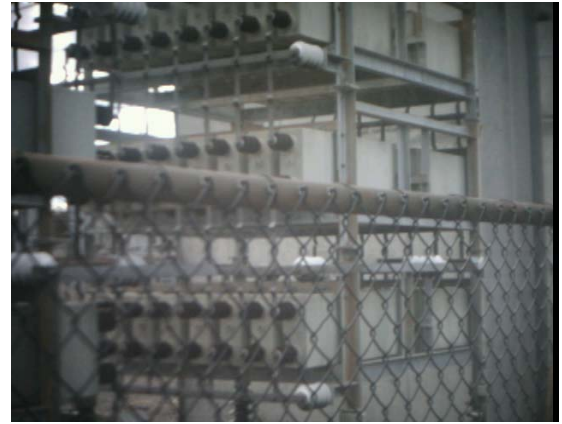
FileName	IR000320.JPG				
CreateTime	8/13/2008 2:38:23 PM				
Emissivity	0.98	Distance	3.0m		
Max Temp	44.2°C	Min Temp	-8.2°C		
Lens	35mm / 22°FOV		Filter	None	
Background Temp	24.9°C				
Location:	Substation				
Equipment:	Capacitor Bank				
Measured Load (Amps)	NA	Rated Load	NA	% Load	
Ambient	20	Temp	45	Rise Over	25
Obj. Priority	Mod	Subj. Priority	Low	Avg. Priority	Low
Environmental:	Partially overcast, 22°C Ambient. Easterly sea breeze.

10°C Rise above allowable (35°C). Subjective priority based on qualitative analysis only. Load is unknown and was unable to be measured at the time. Similar components should all have been under same load, in which case the hotspot is 24°C above the similar components. This objective priority would be a Moderate. Overall, LOW.

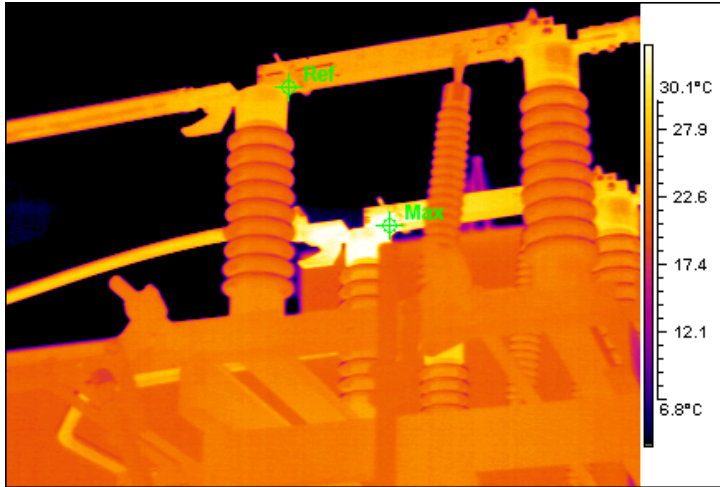
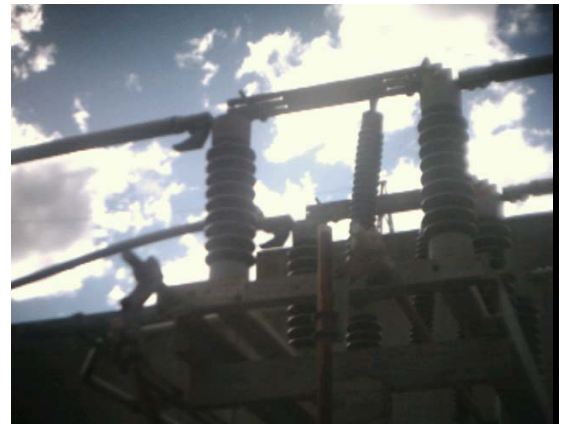
FileName	IR000321.JPG				
CreateTime	8/13/2008 2:38:23 PM				
Emissivity	0.98	Distance	3.0m		
Max Temp	36.7°C	Min Temp	-32.1°C		
Lens	35mm / 22°FOV		Filter	None	
Background Temp	23.9°C				
Location:	NSW XXXX Substation				
Equipment:	Switch				
Measured Load (Amps)	NM	Rated Load		% Load	
Ambient	22	Temp	36	Rise Over	14
Environmental:	Partially overcast, 22°C Ambient. Easterly sea breeze.

Subjective priority based on qualitative analysis only. Measured temp was 14°C over ambient. Load is unknown and was unable to be measured at the time. Absolute temperature rather low, but nevertheless cause for inspection.

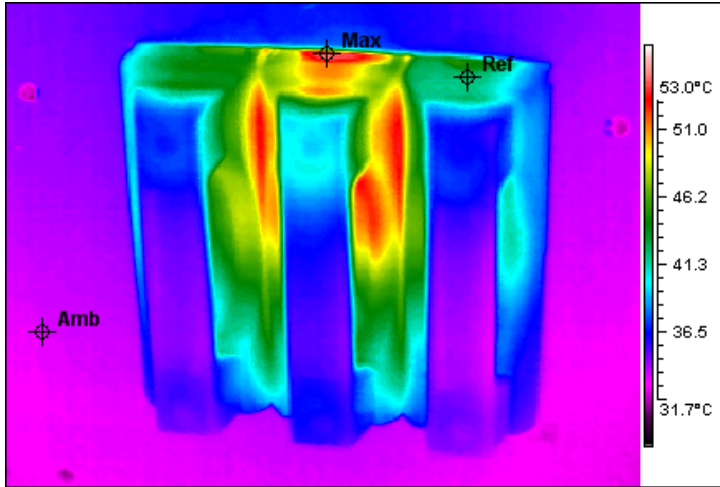
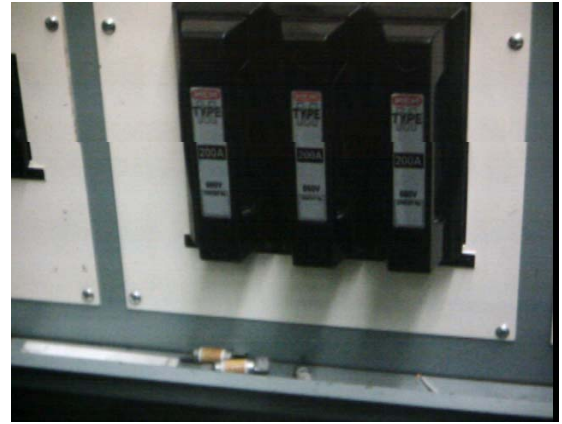
FileName	IR000008.jpg				
CreateTime	3/27/2009 11:35:29 AM				
Emissivity	0.98	Distance	3.0m		
Max Temp	53.0°C	Min Temp	31.0°C		
Lens	35mm / 22°FOV		Filter	None	
Background Temp	24.6°C				
Location:	VIC XXXX Inside Sub Station. Main Switchboard				
Equipment:	Fuse, White Phase.				
Measured Load (Amps)	60	Rated Load	200	% Load	30%
Ambient	33	Temp	53	Rise Over	20

Based on qualitative image only, Fuse is hotter at one end. This localized heat is most likely due to a loose connection at this end. It must be noted that we do not have line of sight to the target, so it is likely that the heat is more significant inside the component. All Fuses were running within similar load, so there is no reason the center phase should be running hotter. Subjectively I would rate this kind of fault as High, especially with the high loads anticipated on this circuit.

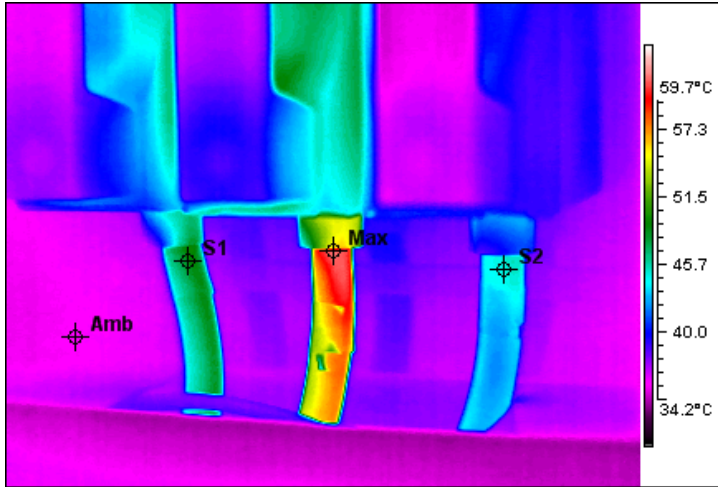
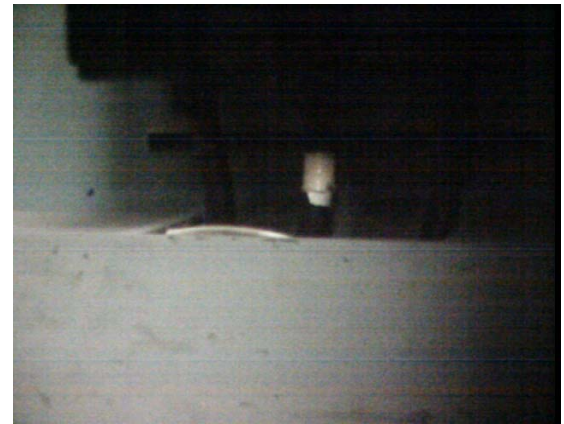
FileName	IR000009.jpg				
CreateTime	3/27/2009 11:36:29 AM				
Emissivity	0.98	Distance	3.0m		
Max Temp	59.7°C	Min Temp	33.5°C		
Lens	35mm / 22°FOV		Filter	None	
Background Temp	25.8°C				
Location:	VIC XXXX Inside Substation				
Equipment:	Circuit Breaker, White Phase				
Measured Load (Amps)	62	Rated Load	200	% Load	31%
Ambient	35	Temp	60	Rise Over	25
Obj. Priority	High	Subj. Priority	Moderate	Avg. Priority	Mod

With the load at only 31%, the Load Corrected Maximum is 39°C. Therefore the measured temp exceeds the allowable by 21° pushing us into the High Priority. Subjectively, it would be a Moderate Fault.

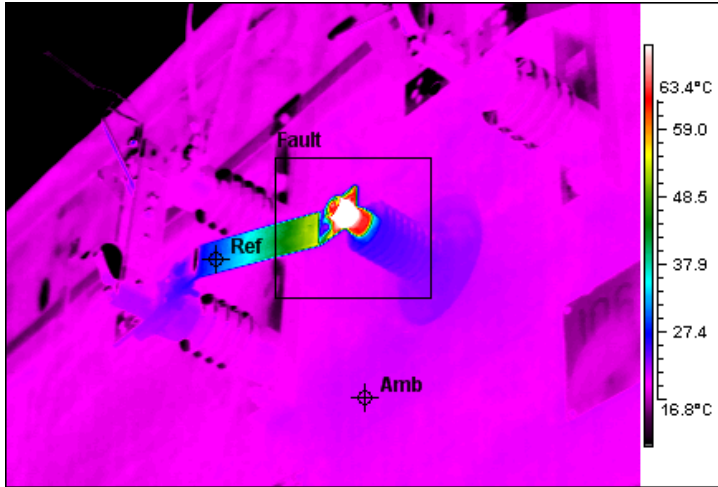
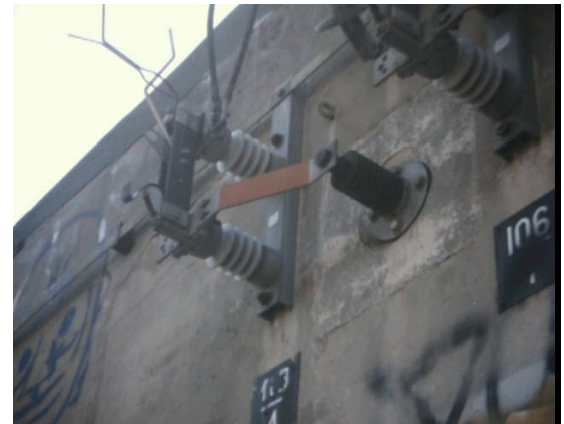
FileName	IR000007.jpg				
CreateTime	3/27/2009 11:27:31 AM				
Emissivity	0.98	Distance	3.0m		
Max Temp	83.5°C	Min Temp	-47.9°C		
Lens	35mm / 22°FOV		Filter	None	
Background Temp	22.5°C				
Location:	VIC XXXX Main Facility Substation				
Equipment:	Line 103 on Southern Wall				
Measured Load (Amps)	300	Rated Load	1000	% Load	30%
Ambient	21	Temp	84	Rise Over	63
Environmental:	Overcast day, not in direct sunlight. Slight Breeze.

Observed temperatures up to 100°C as load varied. Temperature significantly exceeding allowable limits. Cause for immediate investigation.

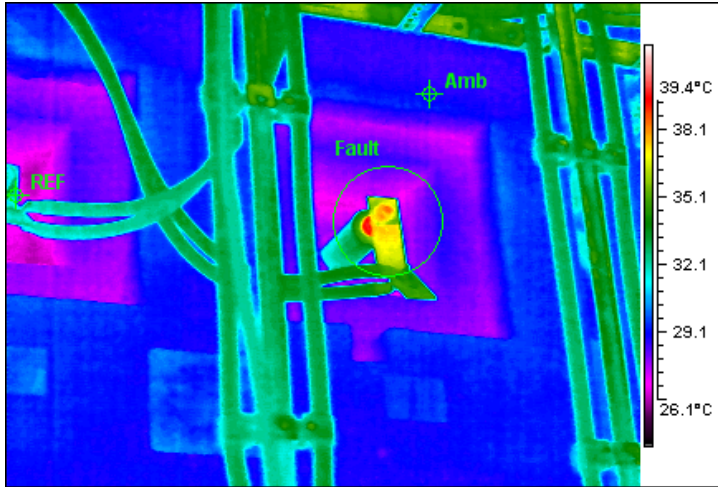
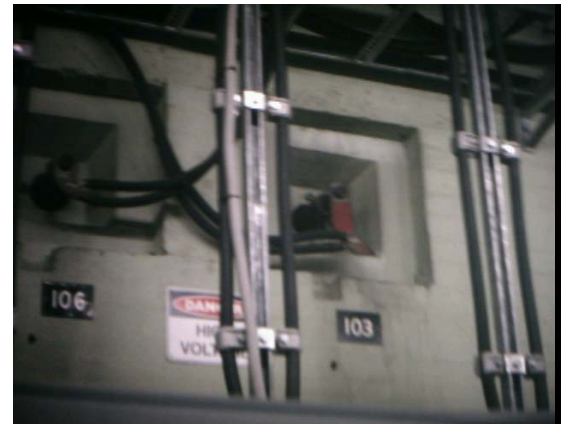
FileName	IR000087.JPG				
CreateTime	3/2/2009 11:45:54 AM				
Emissivity	0.98	Distance	3.0m		
Max Temp	39.4°C	Min Temp	26.1°C		
Lens	35mm / 22°FOV		Filter	None	
Background Temp	28.3°C				
Location:	VIC XXX -Inside Substation				
Equipment:	Line 103				
Measured Load (Amps)	200	Rated Load	1000	% Load	20%
Ambient	28	Temp	40	Rise Over	12

Despite low temperatures on the inside of the building, the conductor is reaching more than 80°C on the outside. This is just conductive heat we are seeing from another condition present on the line.

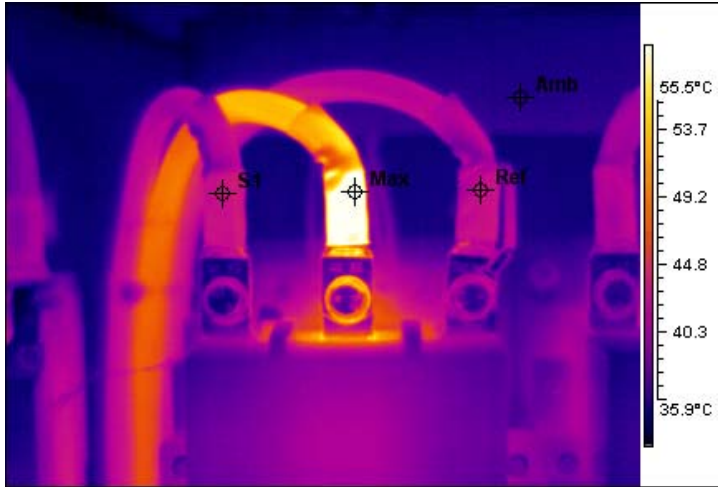
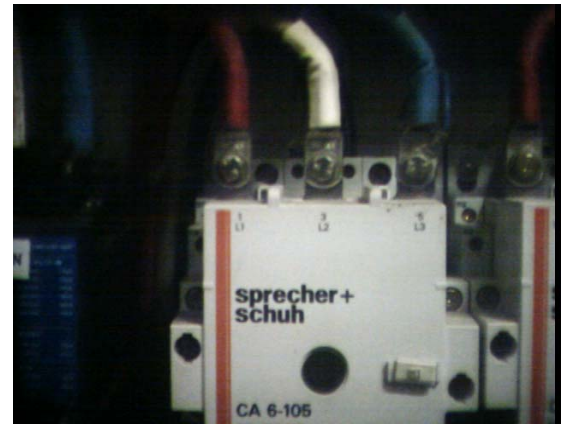
FileName	IR000038.JPG				
CreateTime	2/27/2007 11:42:43 AM				
Emissivity	0.98	Distance	3.0m		
Max Temp	61.0°C	Min Temp	32.4°C		
Lens	35mm / 22°FOV	Filter	None		
Background Temp	28.2°C				
Location:	Longwarry, Mechanical Services Board				
Equipment:	Breaker, White Phase				
Measured Load (Amps)	44	Rated Load	100	% Load	44%
Ambient	35	Temp	61	Rise Over	26
Obj. Priority	Moderate	Subj. Priority	Moderate	Avg. Priority	Moderate
Max Corrected Load	43. Rise over 18.

Significant heating on white phase. Load is similar across phases, so does not account for excess heat. Localized heating typical of loose/deteriorated connection.

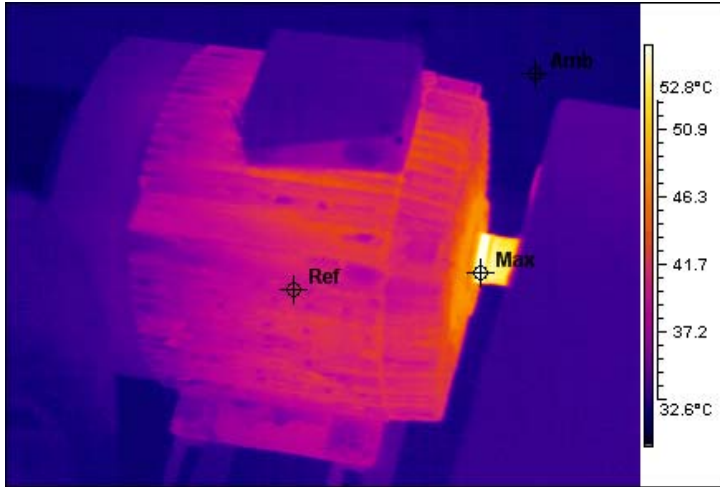
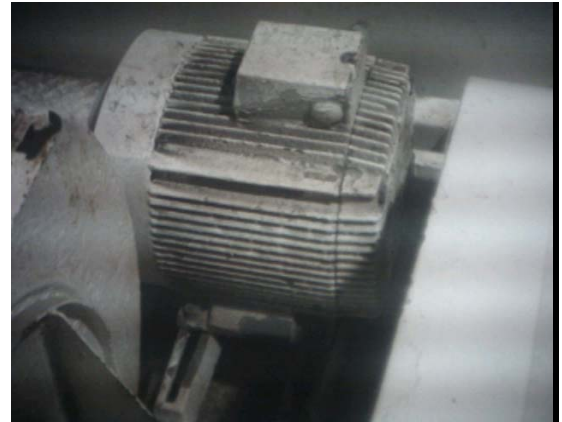
FileName	IR000044.JPG				
CreateTime	2/27/2007 12:01:38 PM				
Emissivity	0.98	Distance	3.0m		
Max Temp	57.6°C	Min Temp	30.3°C		
Lens	35mm / 22°FOV		Filter	None	
Background Temp	27.5°C				
Location:	XXXX Process Line 230				
Equipment:	Motor				
Measured Load (Amps)	NM	Rated Load		% Load	
Ambient	31	Temp	58	Rise Over	27
Obj. Priority		Subj. Priority	Moderate	Avg. Priority

Inexplicable heat on drive shaft.

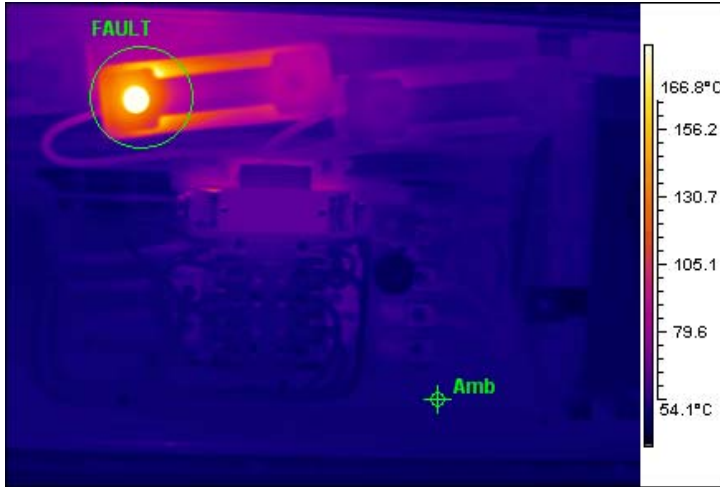
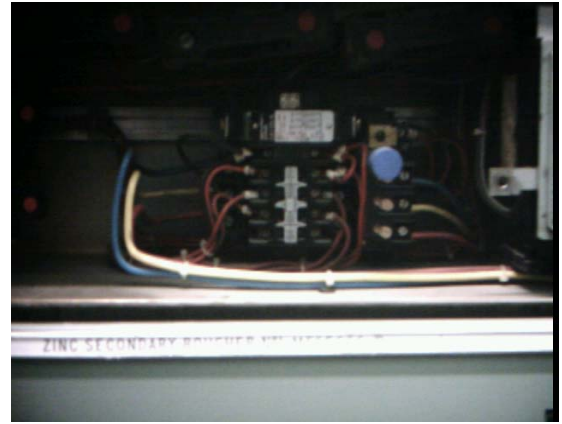
FileName	IR000232.JPG				
CreateTime	2/25/2009 9:53:13 AM				
Emissivity	0.98	Distance	1 m		
Max Temp	223.1°C	Min Temp	33.0°C		
Lens	35mm / 22°FOV		Filter	None	
Background Temp	28.3°C				
Location:	XXXX				
Equipment:	FUSE				
Measured Load (Amps)	NM	Rated Load		% Load	
Ambient	44	Temp	224	Rise Over	180
Obj. Priority	HIGH	Subj. Priority	Extreme	Avg. Priority	Extreme

This extreme temperature should be investigated IMMEDIATELY.
 This was reported immediately to site assistant as an immediate safety issue.

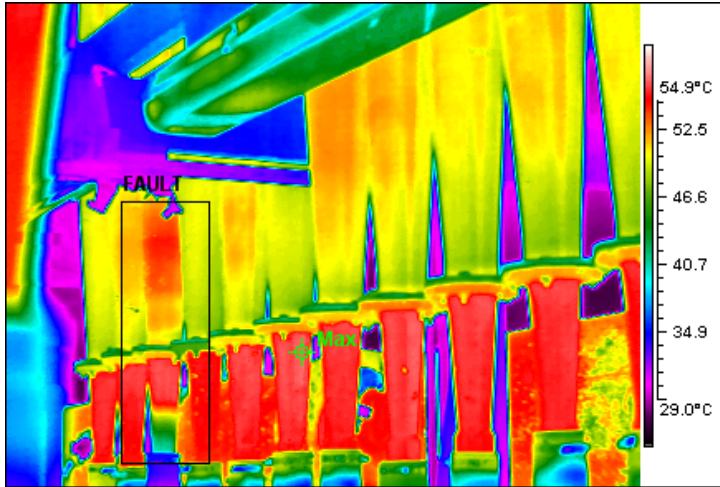
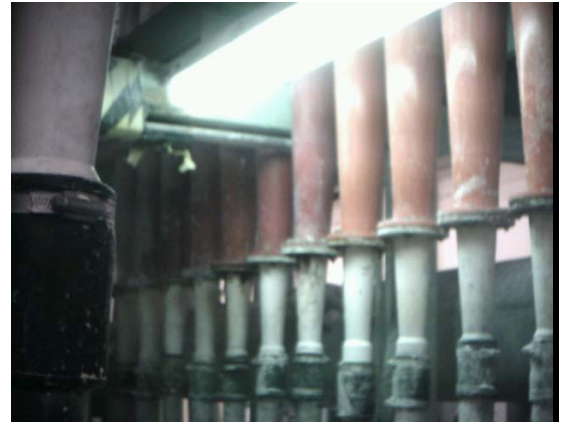
FileName	IR000001.jpg				
CreateTime	9/4/2008 12:42:38 PM				
Emissivity	0.98	Distance	3.0m		
Max Temp	55.7°C	Min Temp	26.4°C		
Lens	35mm / 22° FOV	Filter	None		
Background Temp	21.5°C				
Location:	Norske Skog Tasmania Plant				
Equipment:	Centrifuge Separation Cones				
Measured Load (Amps)	NA	Rated Load	NA	% Load	NA
Ambient	28	Temp	56	Rise Over	
Obj. Priority	Moderate	Subj. Priority	Mod	Avg. Priority	Mod

Third plastic cone counting from the left hand side is wearing very thin in top portion of the cone compared to the others in the train. Cone also blocked in the lower portion. Product has built up and has ceased to flow. Immediate action was taken to stop the flow before it became excessive and a major issue to the feeder plant above. Cone had higher wear rate than others in the train and would be changed on the next shut down
